**FEASIBILITY
STUDY**

**Fire Station No. 10
Eau Claire, Wisconsin**

2010

FIVE

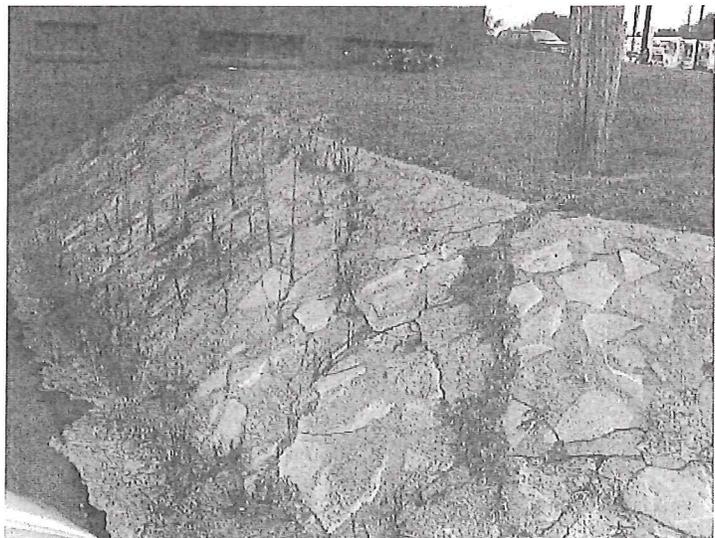
It appears access to the building is adequate and the curb, concrete aprons, and asphalt are in good condition. Recent road work adjacent to the building has accommodated access to the site. The retaining wall on the east side of the building, north of the overhead doors, appears to be old and in poor conditions. There are multiple cracks and concrete deterioration occurring in the structure. A picture of the retaining wall is shown at the right.

After thorough review of the site, it is SEH's recommendation the existing retaining wall be removed and replaced during the building construction. This site improvement is the only item that will require attention in the near future.

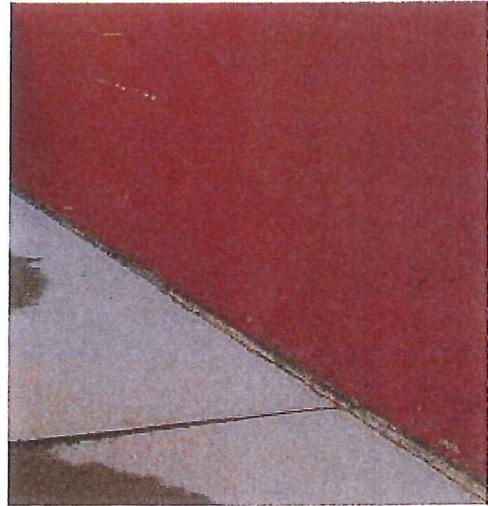
There are portions of the reinforced concrete structure (beams members) that are cracked and damaged. It is recommended that these areas be patched and painted.

- Work is to include patching the cracked and chipped concrete planks and structural members throughout the facility. It will also include the painting of all patched areas.

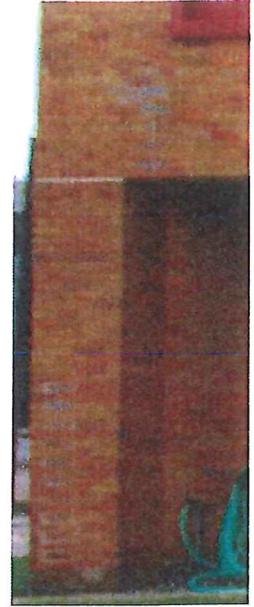
There is vertical cracking occurring above two of the overhead doors. It is advised that control joints be put in above the overhead doors on the west side of the building.

- Work is to consist of creating control joints and caulking at both corners of the overhead doors. In some locations it will also require brick patching and repair.

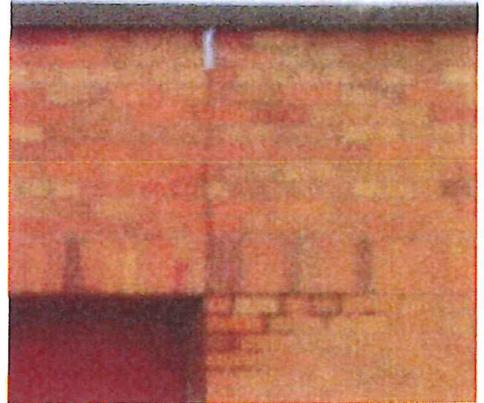
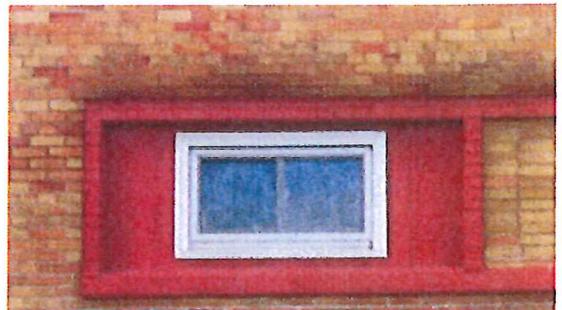
There is discoloration of the brick above the windows on the north and west façades, it is likely caused by moisture remaining within the wall and then leaking out. It is recommended that a portion of the brick above the windows be removed, flashing and weeps to be installed throughout the wall, then the brick is to be patched and repaired.

- Work is to consist of the removal and replacement of approximately 1'-6" of the brick above the windows on the north and west façades. Weeps are to be included above the windows. The existing brick is to be matched as closely as possible.

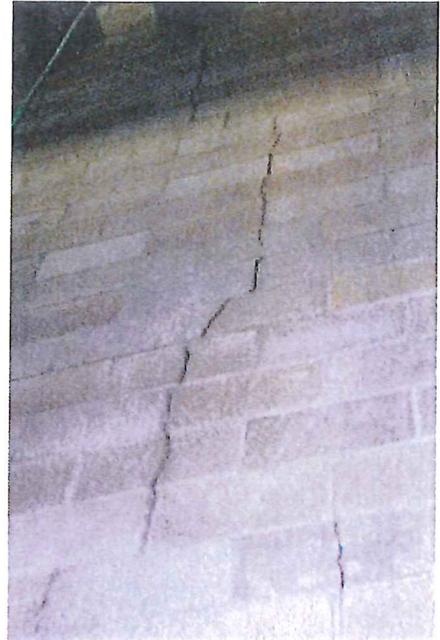
There is damage along the CMU wall in the stair well. It is recommended that the cracked CMU's be replaced. Control joints should also be added to the wall to prevent future cracking.

- Work is to include the removal of cracking CMU's and replacement as well as creating control joints within the wall surface. Control joints would be filled with flexible caulking/sealant material.

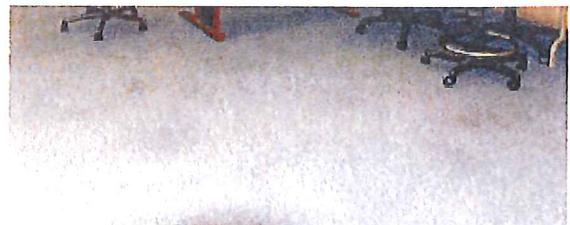
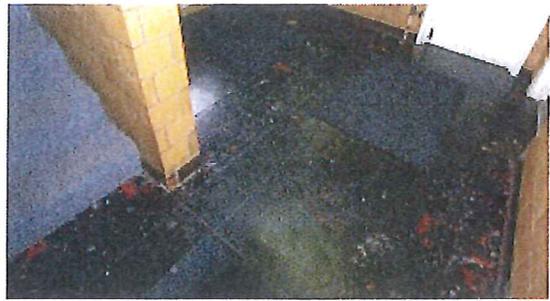
In areas where vinyl composition tile is located the tile is showing signs of age such as scratching, cracking, and slight delaminating along the edges of the tiles. The rubber base along the walls in these areas is also delaminating and in need of replacement. This is a consistent occurrence given the age and use of the tile and adhesive.

- Work is to consist of the removal and replacement of all vinyl composition tile and rubber base.

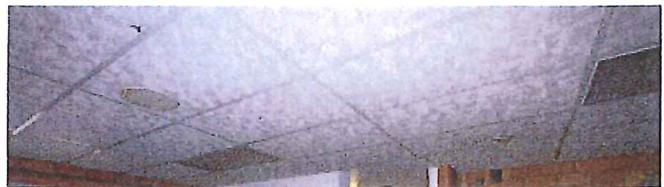
There is currently a 2x4 ceiling tile grid systems within the facility. It is recommended to upgrade the 2x4 grid to a 2x2 ceiling system.

- Work is to consist of the removal of all 2x4 ceiling grid systems and replacement with a 2x2 grid system.

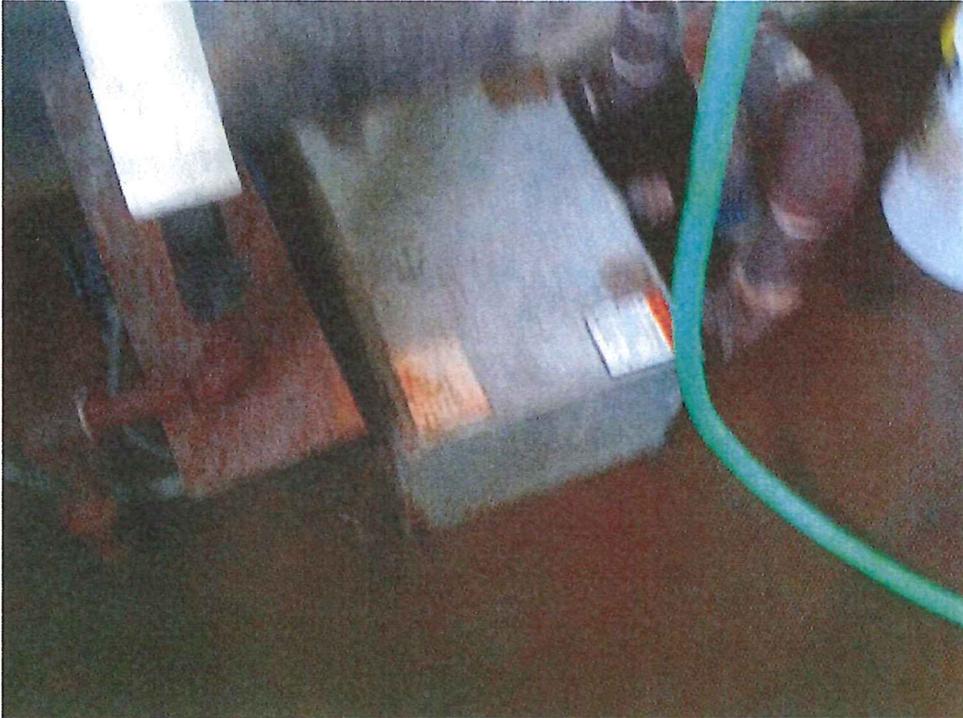
1. Aged and obsolete condensate pump. The condensate pump that serves the boiler is aged beyond its useful life and should be replaced. Estimated cost - \$4,000

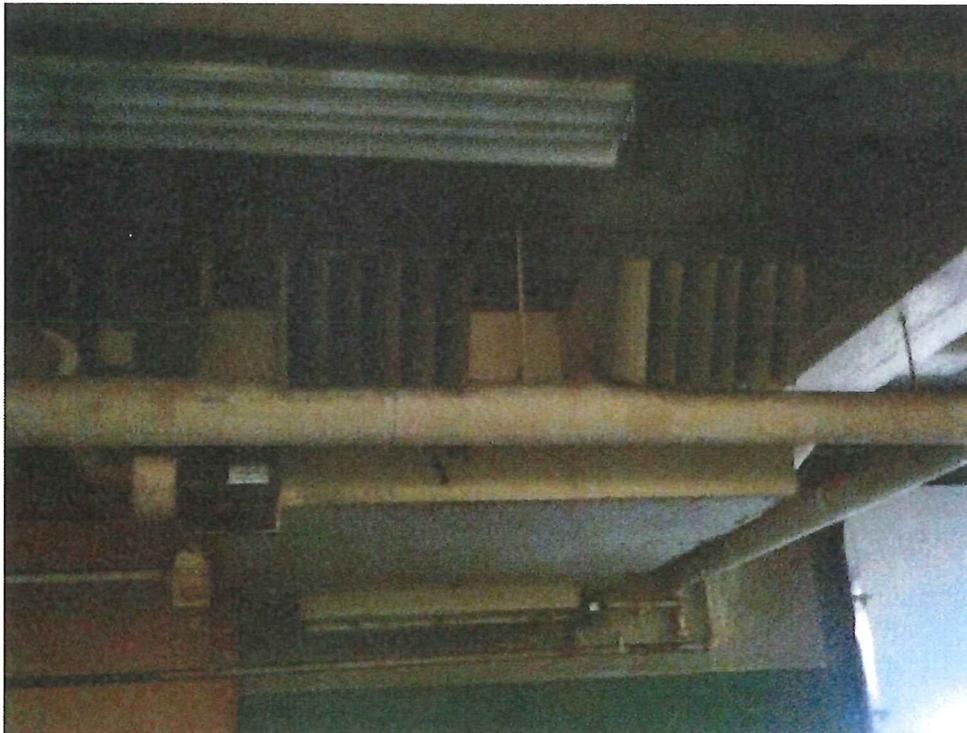
3. Aged Makeup Air Units – The makeup air units serving the Apparatus floor, and the repair & storage garage are aged and should be replaced, and controlled to interlock with new exhaust fans to serve the floors. IMC and Wisconsin codes require exhaust within 18" of the floor. This exhaust must run whenever the area is occupied, or must run a minimum of 5 hours per day, with Carbon Monoxide and Nitrous Oxide sensors to override the timer. See note 4 for cost.

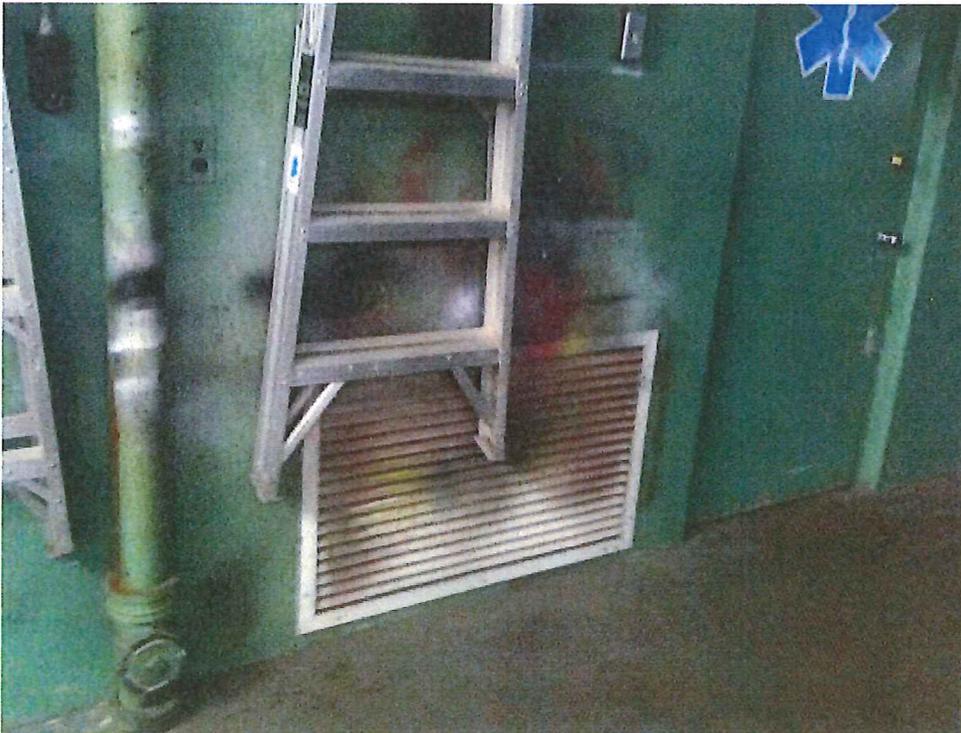
4. S1 Occupancy Exhaust required within 18" of floor – The ducts and grilles are present to provide exhaust from within 18" of the floor in the Apparatus area, and the repair/storage garage in the lower level, but the fan has been inoperable for several years. International Mechanical Code (IMC) and Wisconsin codes require exhaust within 18" of the floor. This exhaust must run whenever the area is occupied, or must run a minimum of 5 hours per day, with Carbon Monoxide and Nitrous Oxide sensors to override the timer. Total cost for new exhaust fan, with makeup air and controls. - \$31,000. If an energy recovery ventilator is used instead of the exhaust fan and makeup air, the cost would be approximately \$38,000, but the payback would be very short.

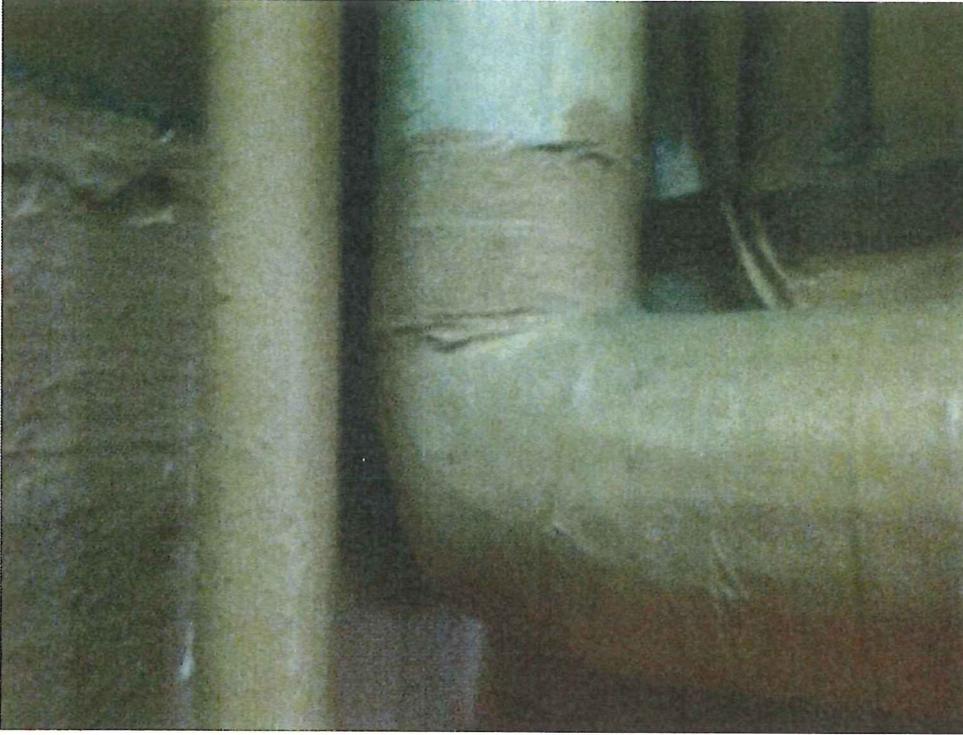
5. Possible Asbestos - The fittings on the steam pipes are insulated with a material that appears to be Asbestos Containing Material (ACM). It is recommended that the materials be tested, and removed, if ACM. Estimate for testing - \$\$2500. Estimate for removal and replacement - \$12,500.

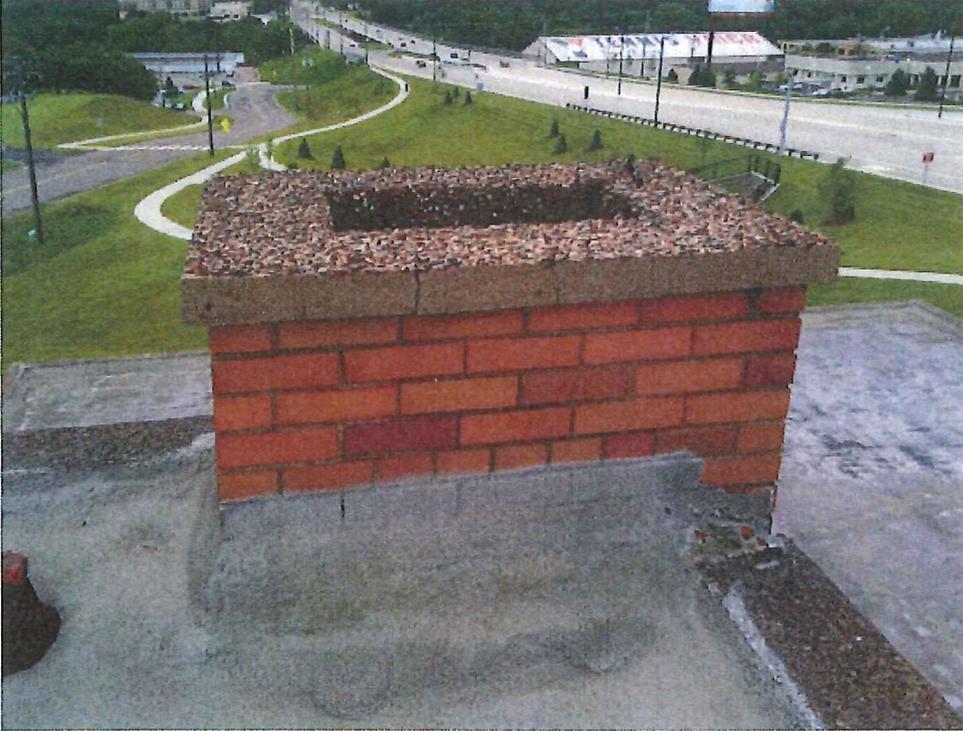
6. Aged Chimney – The chimney serving the boiler is showing signs of age. The liner has some cracks that could allow Carbon Monoxide to seep into the building. It is recommended that the chimney be replaced in conjunction with a new boiler. See Note 7 for cost estimate on boiler and chimney.

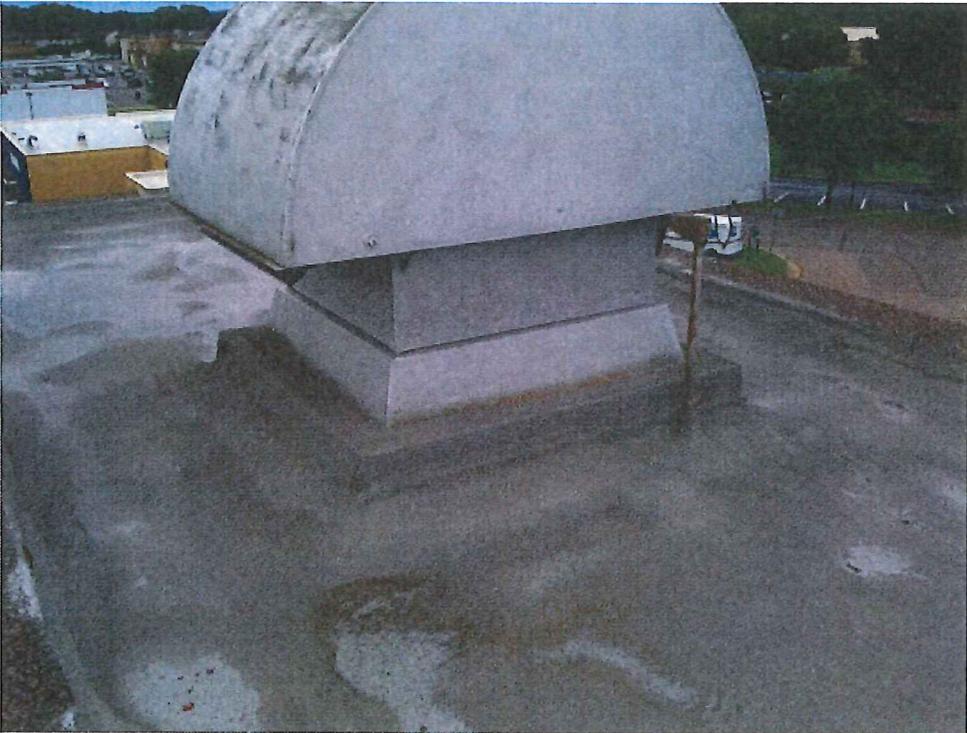
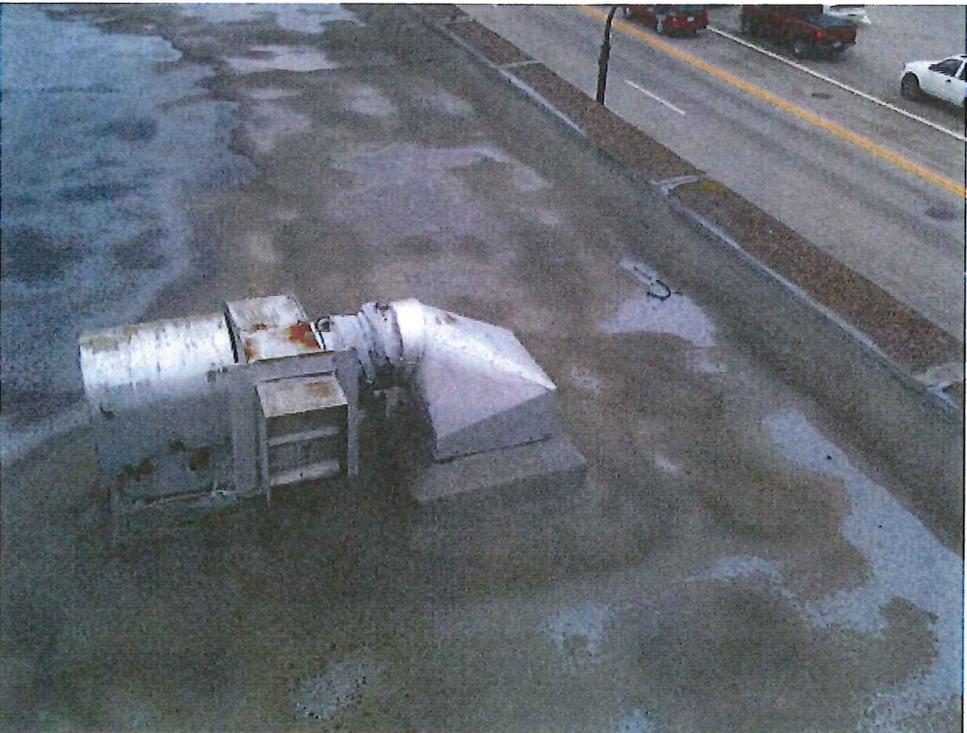
- 8. Garage & Apparatus Floor Exhaust Fan – Replacement included in note 4. Above, but the fan is less than 10 feet from the edge of the roof. A guard rail should be installed to assure life safety for fans less than 10 feet from edge. Estimated cost \$5,500.

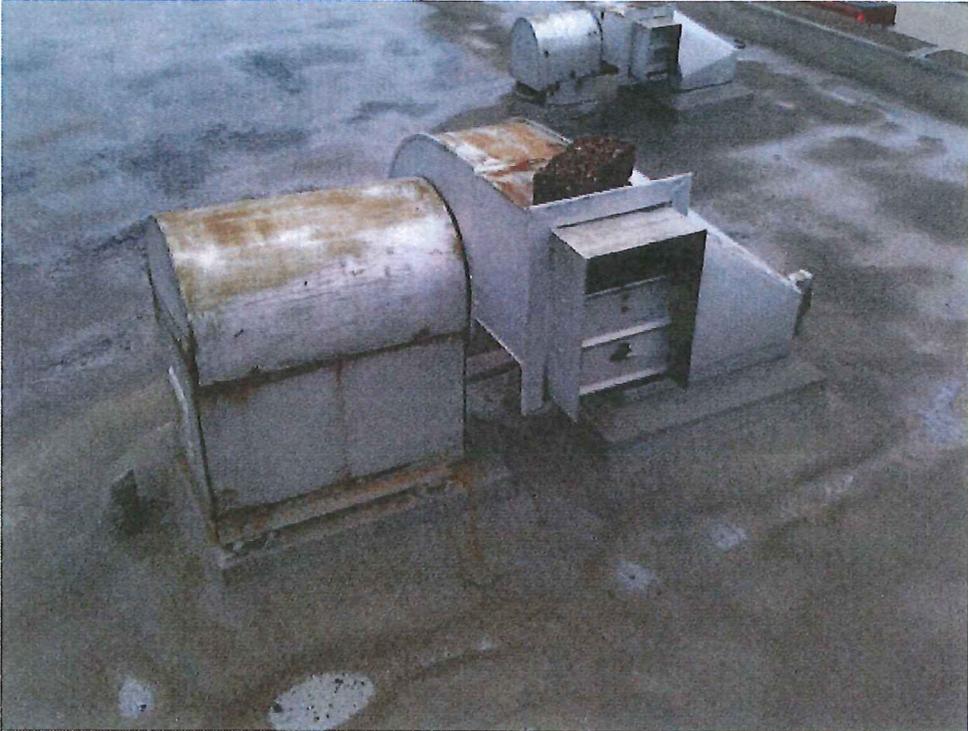
- 9. Aged and Inoperable fan. It is not known what the fan serves. It appears to be above the kitchen, but does not run, and is not approved for grease duct exhaust. The fan should be removed and roof patched, or determination made on its use, and the fan replaced. \$1,500 estimate to remove and cap, \$4,500 to replace with a similar type.

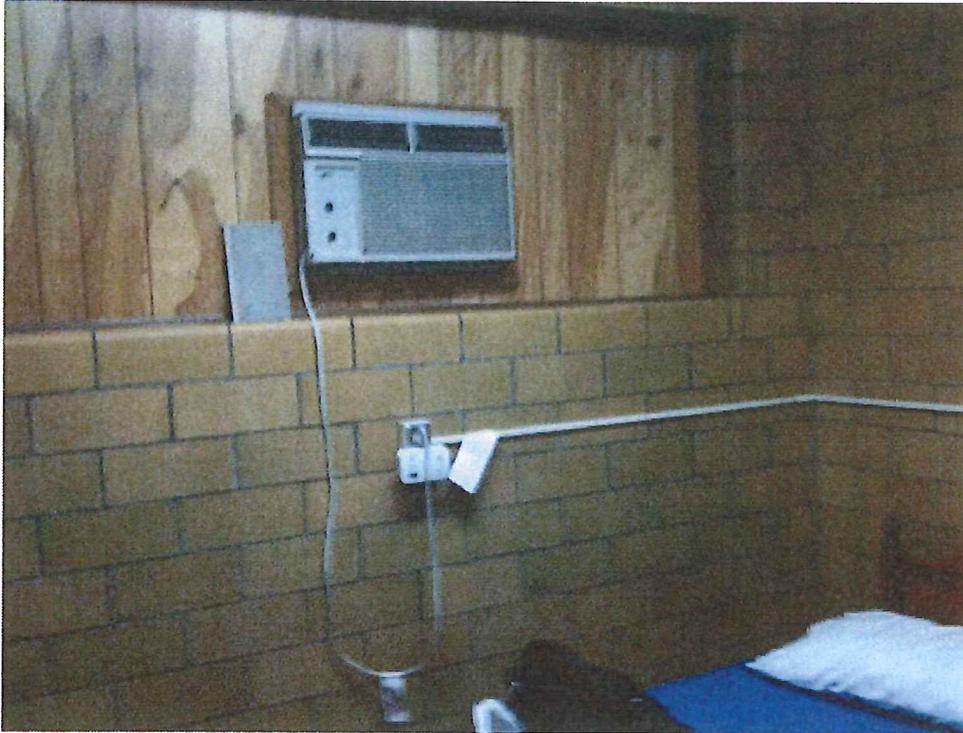
10. Dormitory area and offices have no ventilation. When the building was built, it was ok to provide operable windows in lieu of ventilation. The windows were removed, so the space does not meet codes for minimum ventilation. This is an indoor air quality issue that should be resolved. Estimated cost for an energy recovery ventilator for each floor. \$24,000.

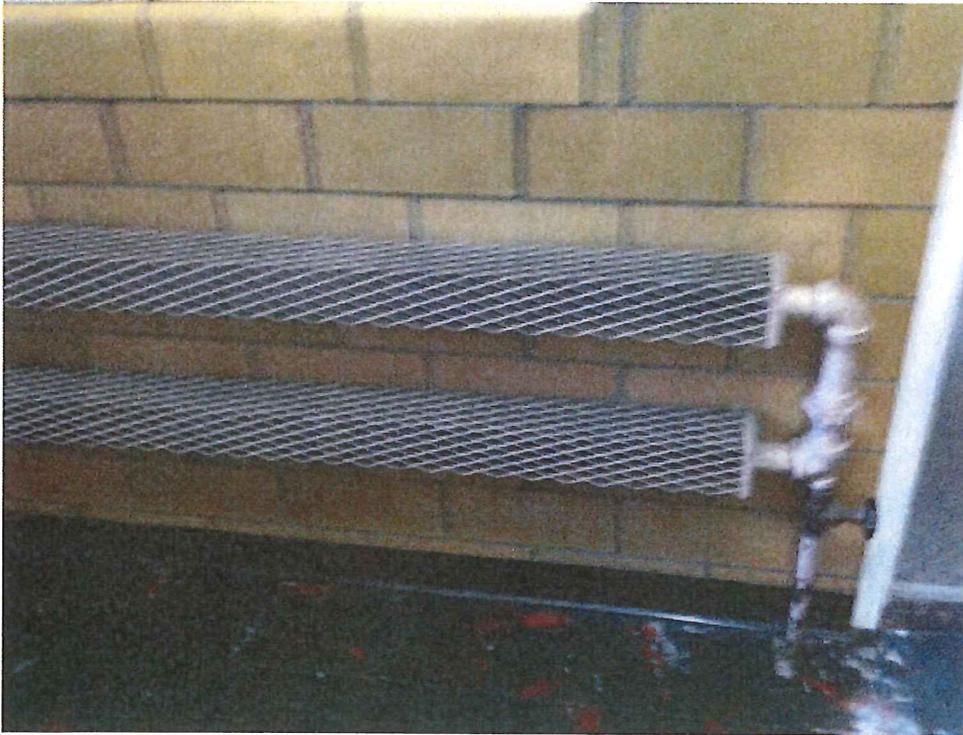
11. Aged wall fin radiation and distribution piping – The existing wall fin radiant heat is aged, and beyond its useful life. The steam pipe and radiant elements are likely calcified. Steam leaks can be costly to repair, and calcification will prevent efficient heat transfer. It is recommended that sample sections of the pipe be removed to inspect the pipe and radiant elements to inspect the actual condition. Estimated cost of inspection \$1,800. Estimated cost of replacement - \$25,000 - \$30,000

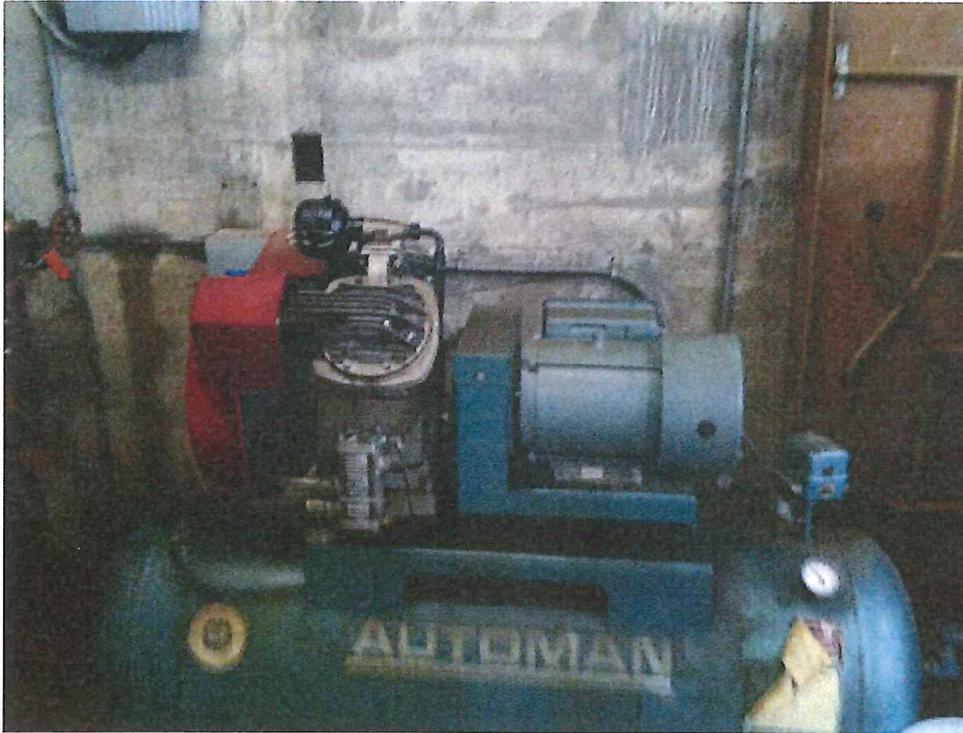
12. Aged Controls – The current controls are minimal, and provided by pneumatics. The pneumatic tubing gets water inside, and corrodes, creating leaks that affect comfort and control. The system cannot provide energy saving logic, and consideration should be given to replacing with Direct Digital Controls (DDC). Estimated cost of DDC for current systems \$25,000. Estimated cost with upgraded equipment \$32,000.

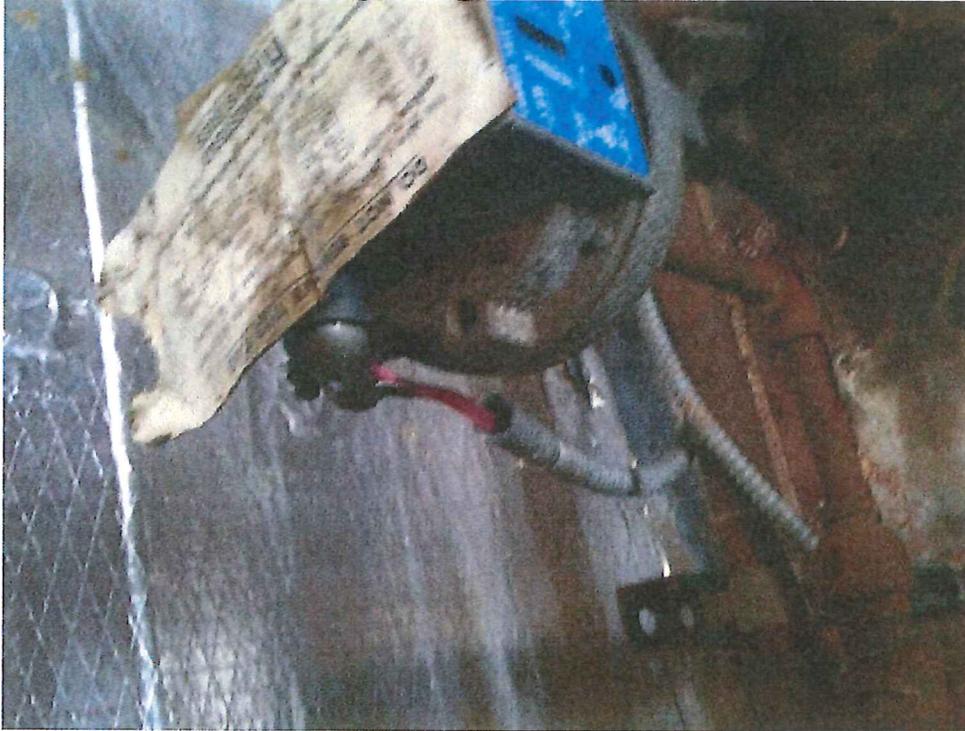
1. Damaged Conduit (Life Safety) – A conduit in the boiler room has been broken loose, and should be repaired, to prevent injury. Estimated cost - \$300.

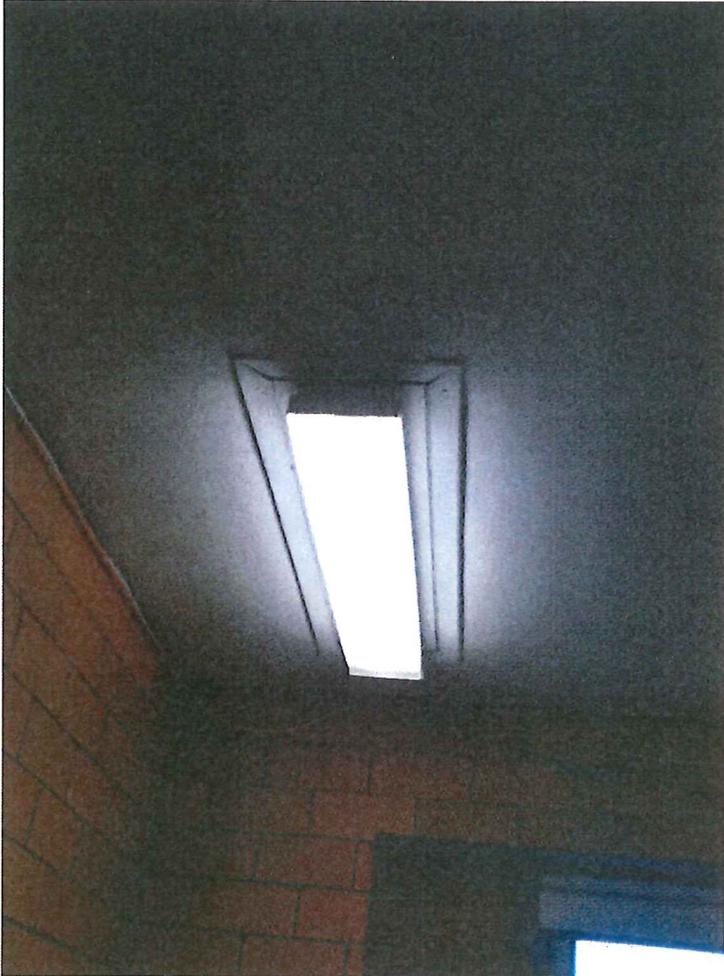
2. Aged and Inadequate Lighting – The lighting throughout the building is inadequate and aged. It does not provide a good image to the public, and does not appear to provide the minimum foot candles required, especially in the office area. Estimated cost to replace lighting throughout building - \$45,000.

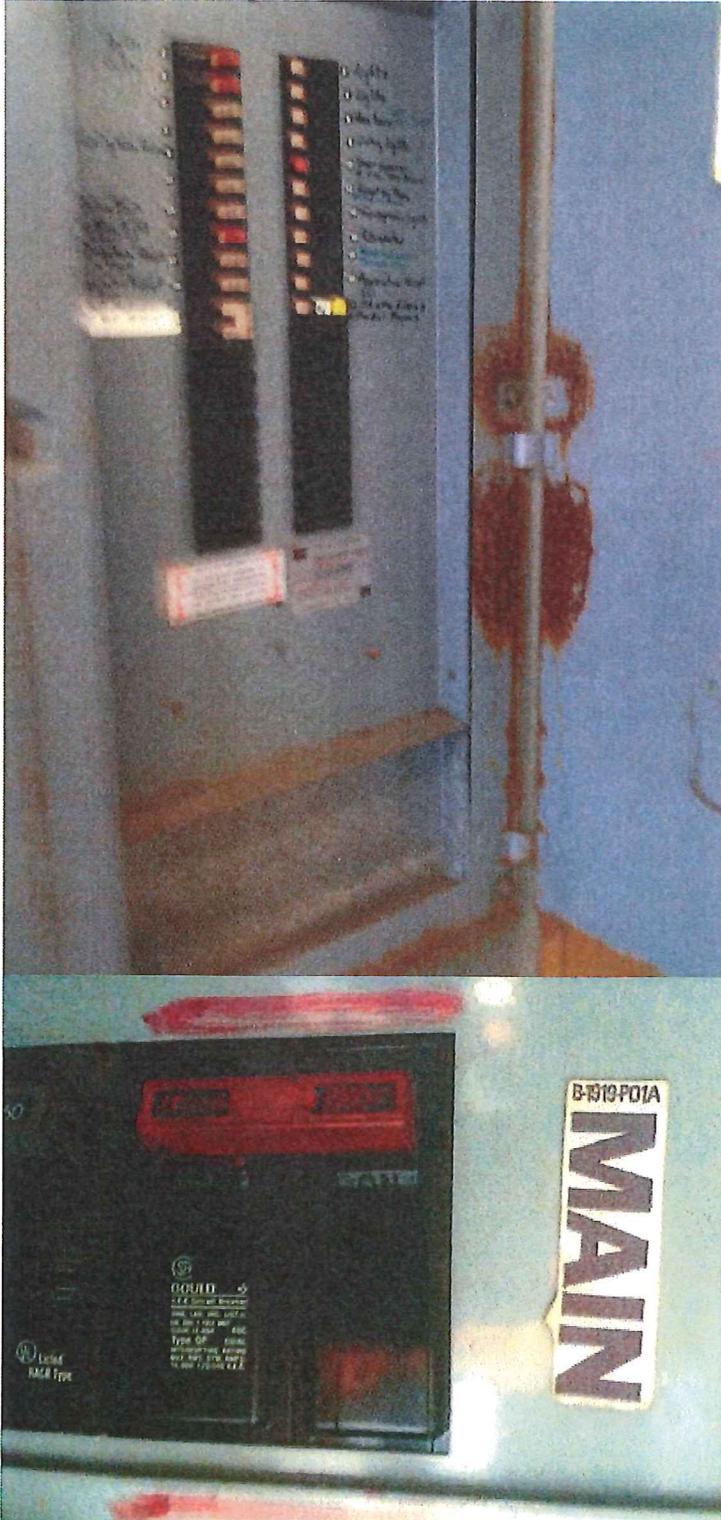
3. Aged Electrical Distribution – The existing electrical distribution consists of aged panels and wiring. It may be hard to find repair parts for the panels, and the wiring may be getting brittle from the heat produced when electrons flow through the circuits. The panels should be replaced, and at a minimum, the wiring should be tested. Estimated cost for the panels, including the main - \$18,000.

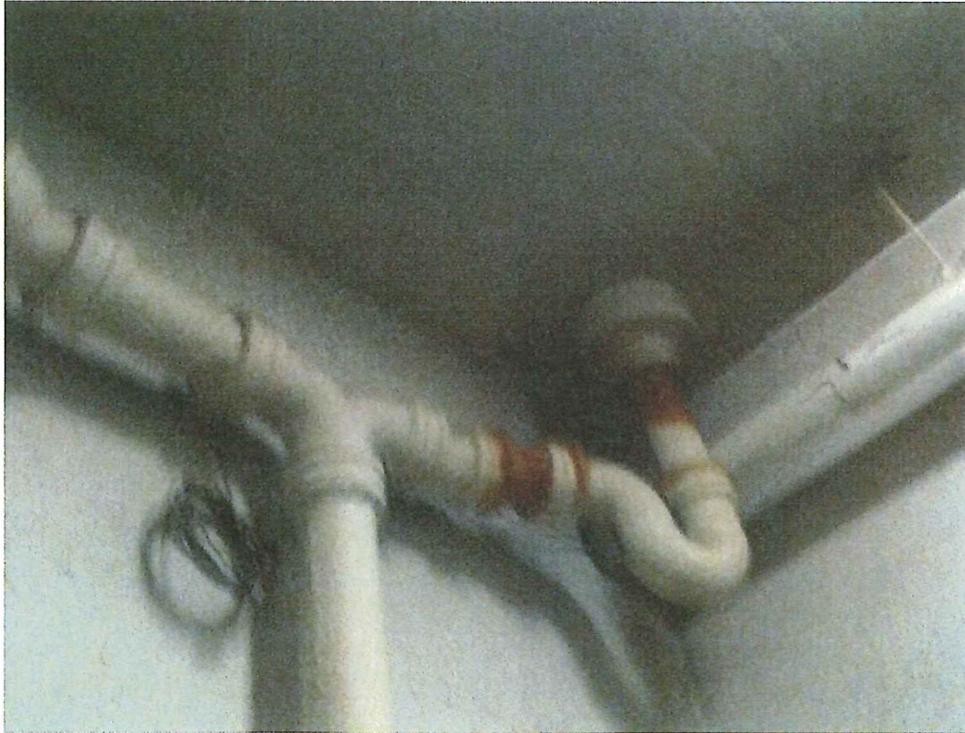
1. Drain waste and vent piping is aged beyond its estimated life. The piping should be tested to determine the integrity of the pipe. Estimated cost for testing - \$2,000. Estimated replacement of above ground pipes - \$32,000. Estimated cost of replacing underground piping - \$42,000.

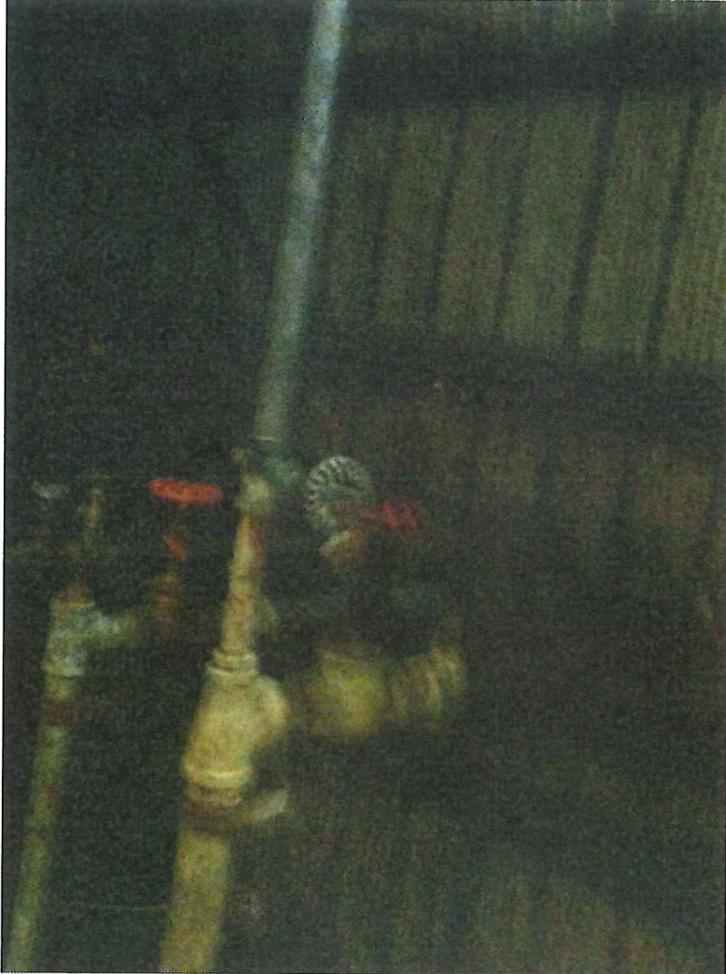
2. Water piping aged – the water piping is aged beyond its expected life. The piping should be tested to determine integrity, and replaced if the pipe is damaged. The cost to replace under emergency situation will cost considerably more. Estimated testing cost - \$2,500. Estimated replacement - \$24,000.

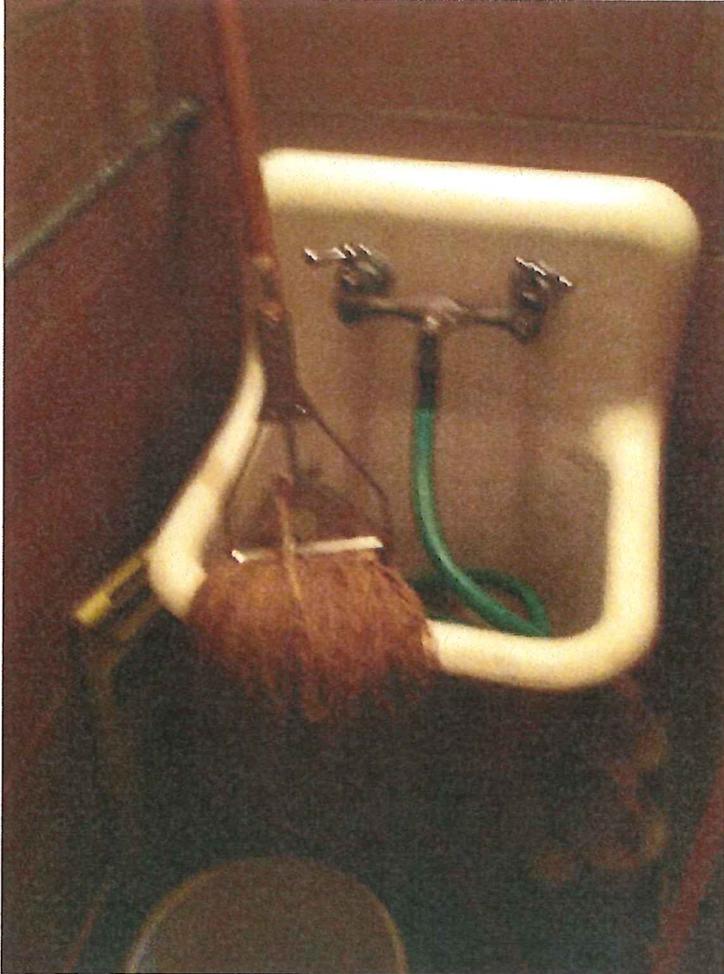
3. Aged Fixtures – The plumbing fixtures are all aged, and do not contribute to employee morale, or public expectation of the corporate image of the Eau Claire Fire Department. The janitor sinks need to have vacuum breakers installed to prevent backflow from the sinks, into the water potable system. Estimated cost of replacement with good quality, low flow fixtures - \$12,500
