Pedestrian Bridge Inspection Report

Inspection Date: 11/18/2020

Structure Number: PEDBR-07

Feature On: "High Bridge" RR Pedestrian Bridge

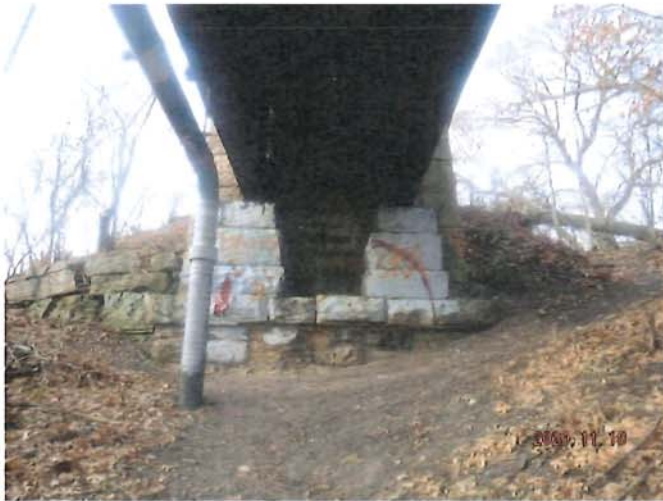
West Abutment

Base of west abutment is deteriorating. Fair Condition. East Abutment is in good condition.

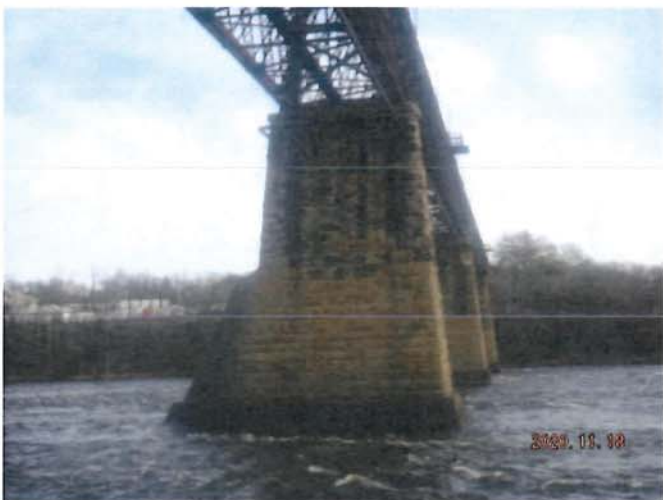
West Face of Pier 2

At Pier 2, the top 2 layers of stone at the upstream nose are cracked.

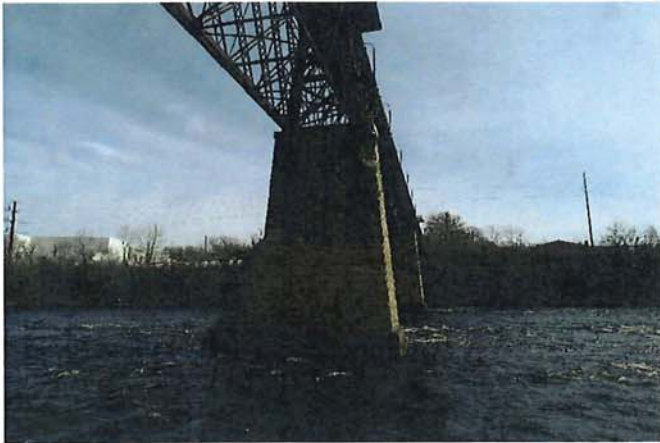
West Face of Pier 3

At Pier 3, the top 7 stones at the upstream nose are cracked.

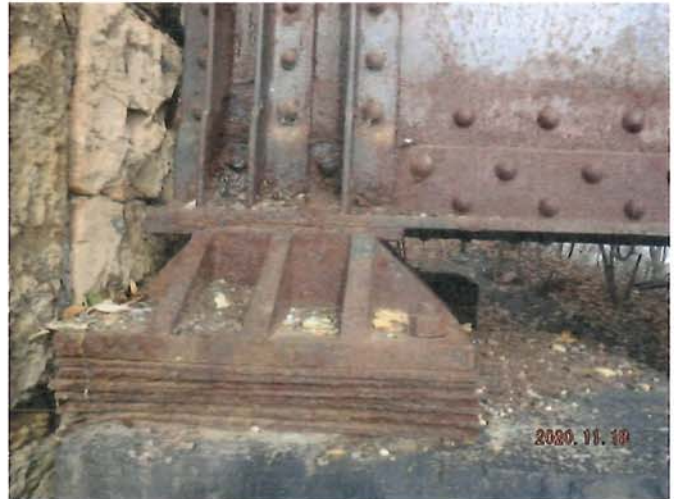
Typical Bearing at West Abutment

Bearing plates at east abutment are wood block (2 – 4"x6"). Good condition. Bearing at west abutment are within alignment limits and bolts show no sign of distress or misalignment. Satisfactory Condition.

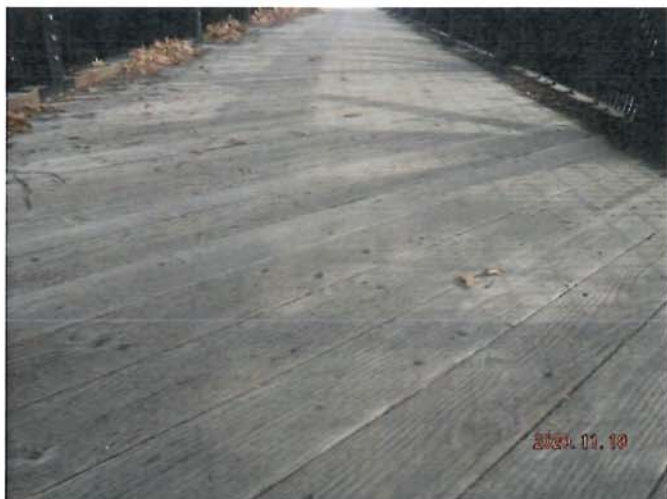
Typical Deck Condition

Deck (RR Ties): Minor areas of water ponding on deck. Good Condition.

Mitigate ponding on deck.
