**FEASIBILITY
STUDY**

**Fire Station No. 10
Eau Claire, Wisconsin**

2010

FIVE

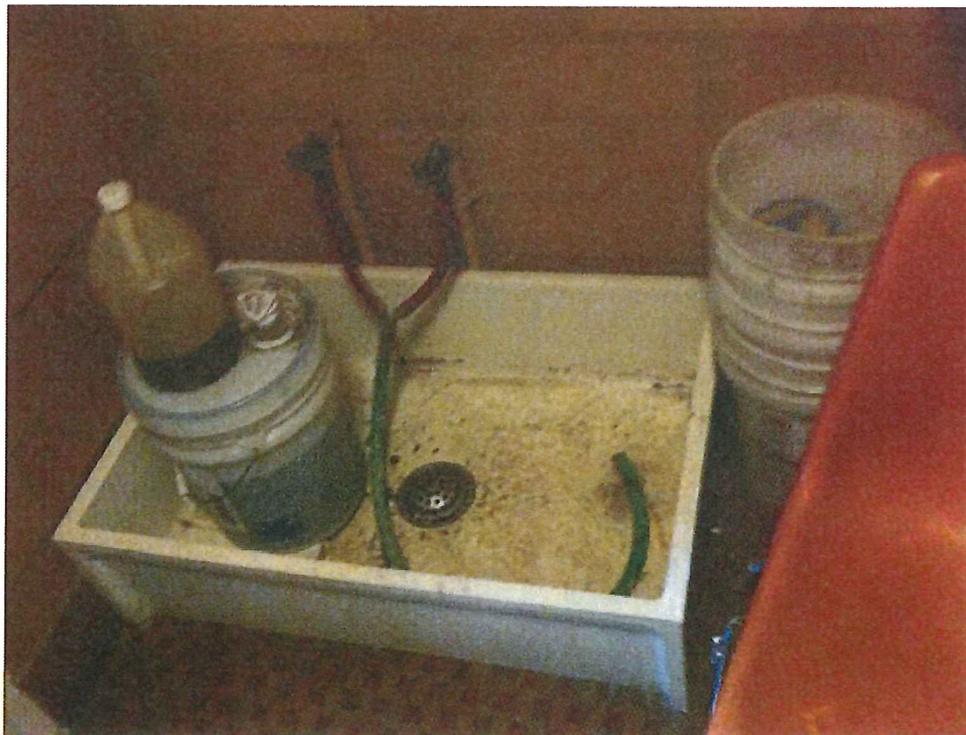
3. Aged Fixtures – The plumbing fixtures are all aged, and do not contribute to employee morale, or public expectation of the corporate image of the Eau Claire Fire Department. The janitor sinks need to have vacuum breakers installed to prevent backflow from the sinks, into the water potable system. Estimated cost of replacement with good quality, low flow fixtures - \$12,500
